**FINAL
BARRIER WALL EXTRACTION SYSTEM
OFF-SITE AREA UPGRADES
CONSTRUCTION COMPLETION REPORT**

**AMERICAN CHEMICAL SERVICE INC.
NPL SITE
GRIFFITH, INDIANA**

**MWH
27755 Diehl Road, Suite 300
Warrenville, Illinois 60555**

March 2003

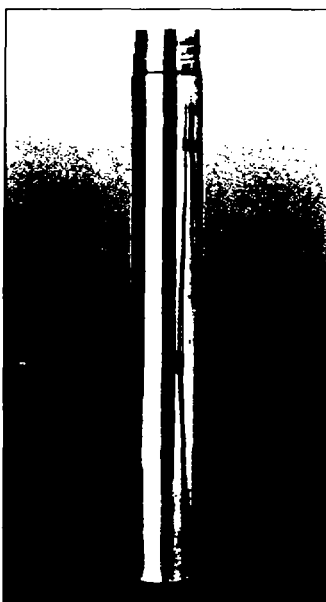
Riser body is available in schedules 5, 10 or 40. Threads are ASTM F-480a (flush joint) made from schedule 40 material.

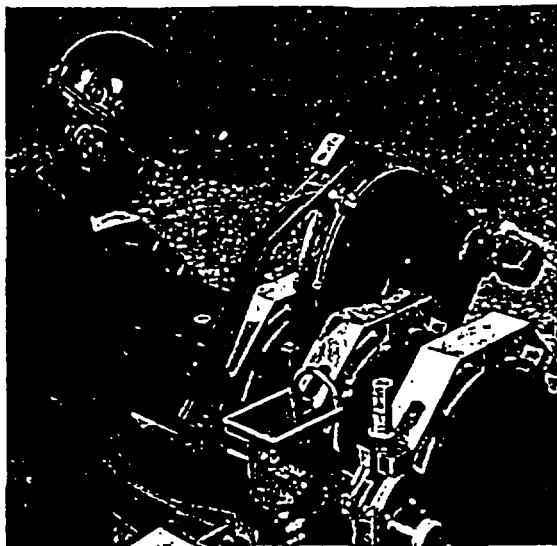
The self-contained No. 412 Hydraulic Fusion Machine's semi-automatic hydraulic control system is energy efficient and requires no auxiliary power to perform butt fusion easily. It is also available in an electric model No. 412E.

The butt fusion heater has replaceable, bolt-on butt fusion heater adapters coated with a durable, antistick coating. Heater temperature is accurately controlled by an externally adjustable thermostat. A dial thermometer allows the operator to monitor heater temperature and its dual handles aid in easy operation.
